Your Inspection Report

123 Somestreet Ave
Durham Region, ON

INSPECTION DATE:
Friday, April 19, 2013

RE: Report No. 1148, v.2
123 Somestreet Ave
Durham Region, ON

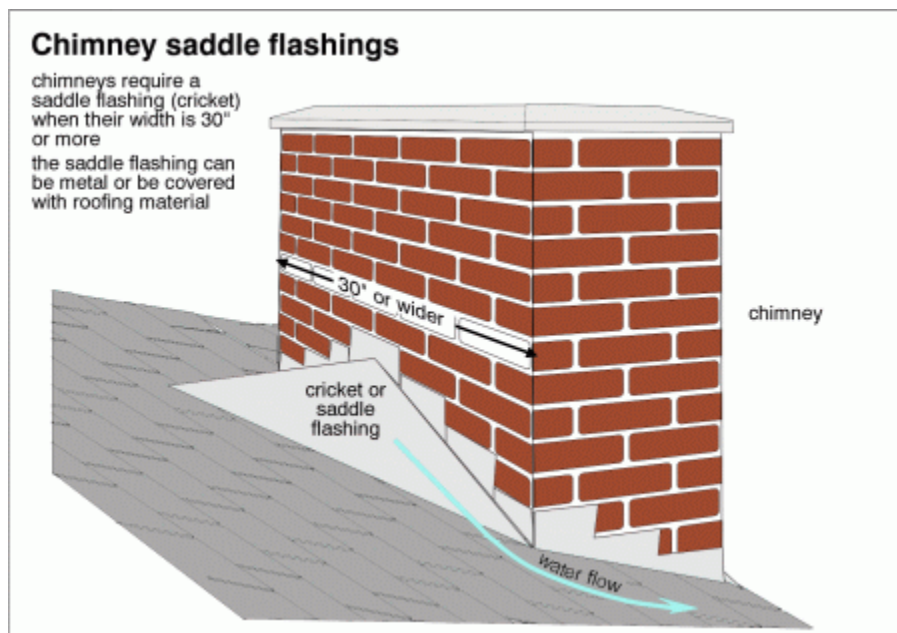
SLOPED ROOF FLASHINGS \ Chimney flashings

Condition: • [Cricket missing, loose, damaged](#)

Implication(s): Chance of water damage to contents, finishes and/or structure

Task: Replace

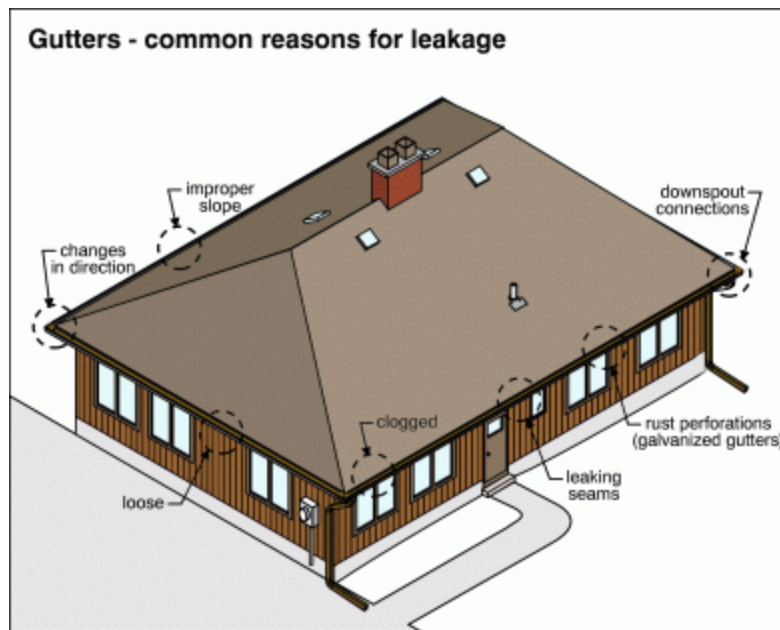
ROOF DRAINAGE \ Gutters

Condition: • [Loose or damaged](#)

Implication(s): Chance of water damage to contents, finishes and/or structure

Task: Repair

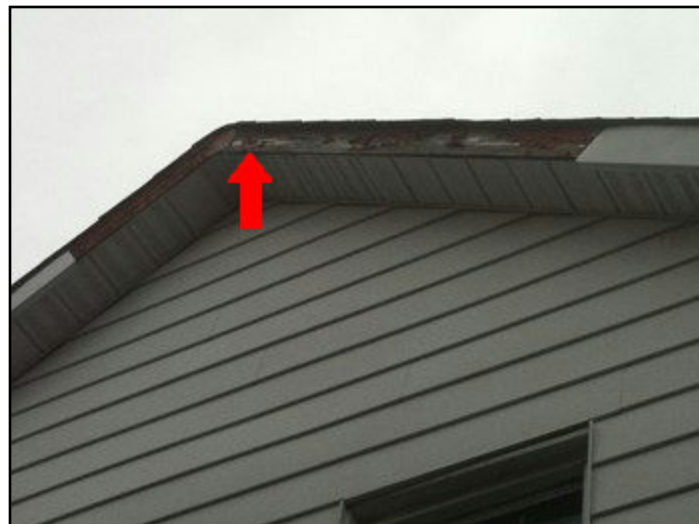
WALLS \ Brick, stone and concrete

Condition: • Gap

Task: Repair

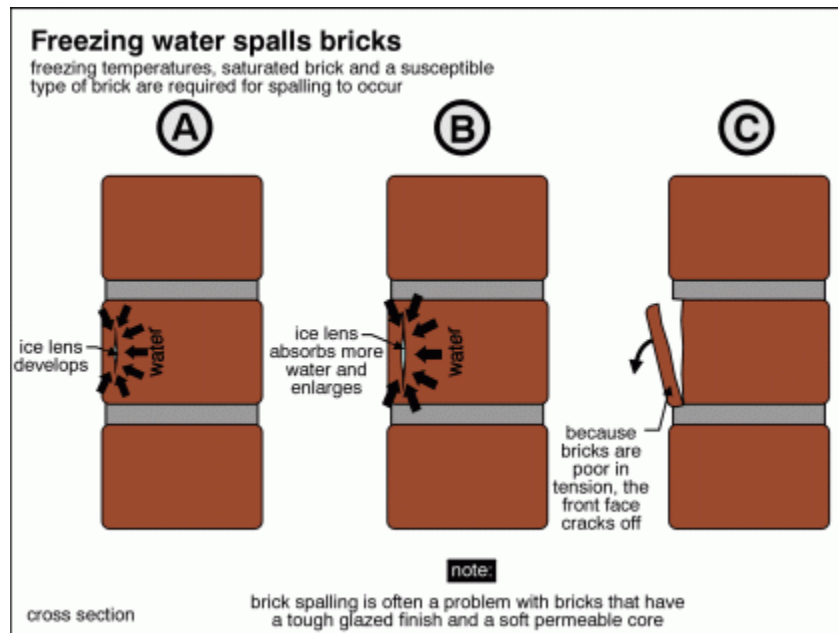
Condition: • [Spalling](#)

Implication(s): Cosmetic defects | Weakened structure | Chance of structural movement

Task: Repair or replace

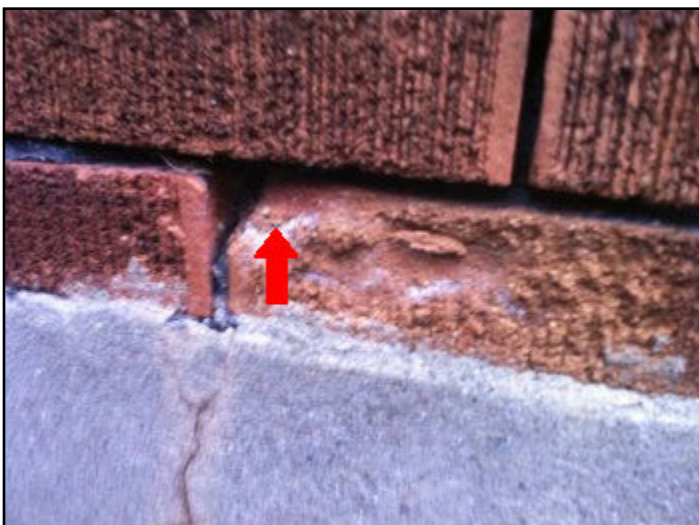
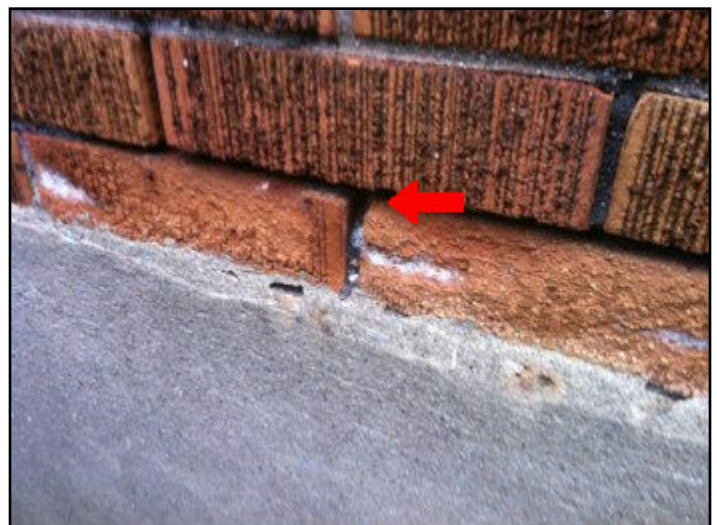
Condition: • [Mortar deterioration](#)

Implication(s): Chance of water entering house | Weakened structure | Chance of structural movement

Task: Repair

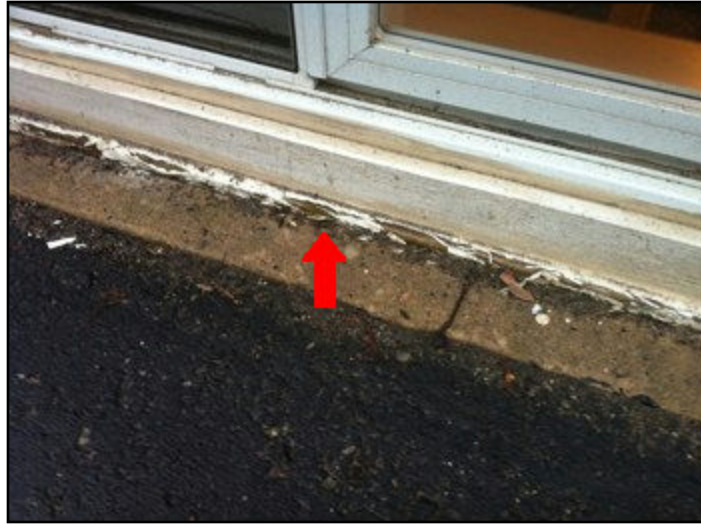
Condition: • [Caulking loose, missing or deteriorated](#)

Implication(s): Chance of water damage to contents, finishes and/or structure | Increased heating and cooling costs

Task: Replace

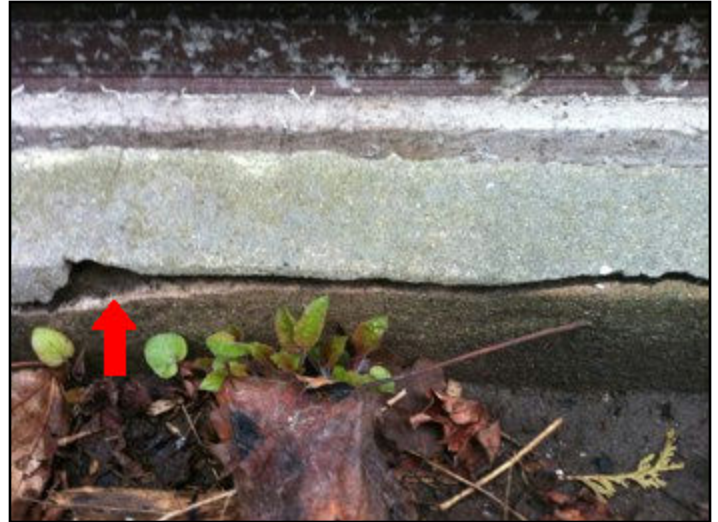
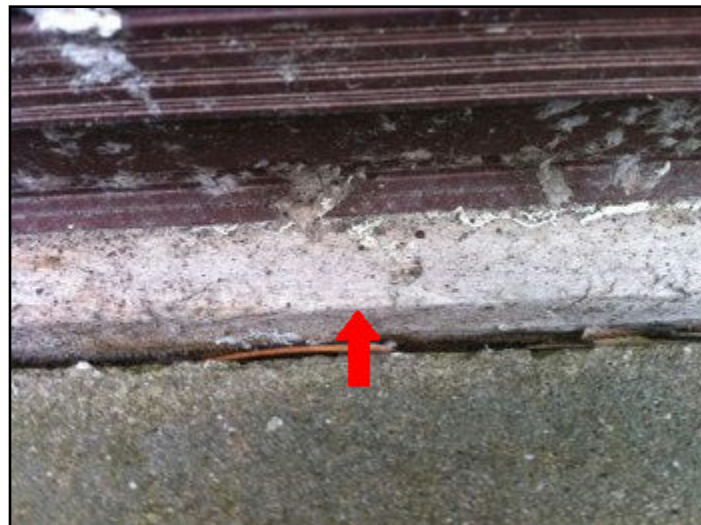
FOUNDATIONS \ Foundation

Condition: • Typical minor cracks

Task: Monitor

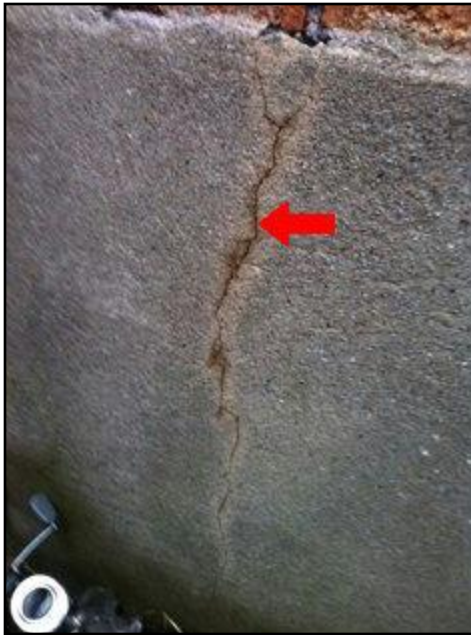
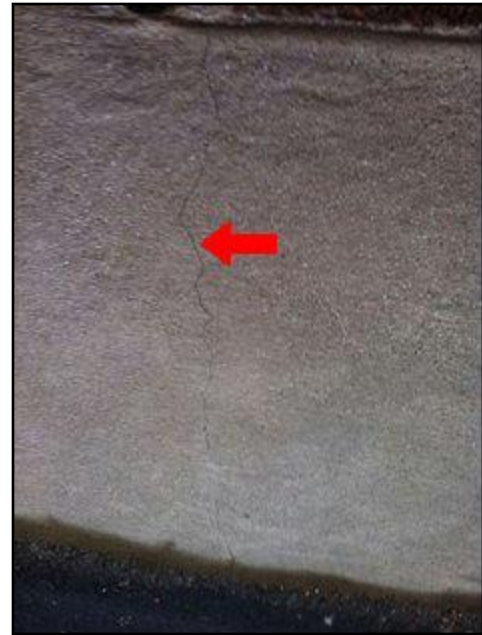
Condition: • [Spalling, crumbling or broken material](#)

Implication(s): Weakened structure | Chance of structural movement

Task: Repair

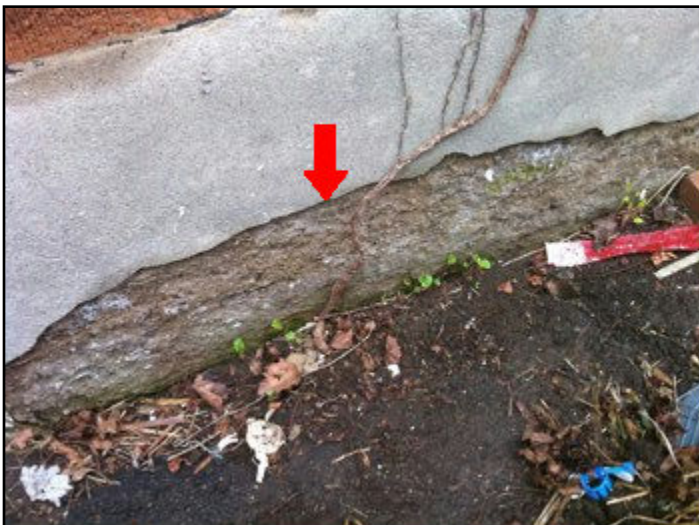
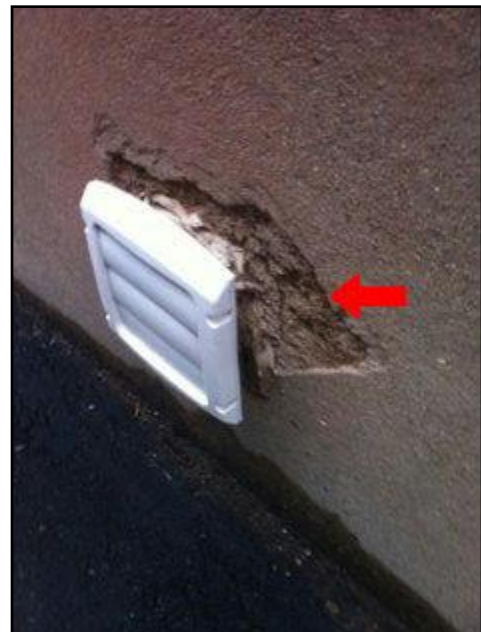
Condition: • [Parging damaged or missing](#)

Implication(s): Chance of damage to structure | Shortened life expectancy of material

Task: Repair or replace

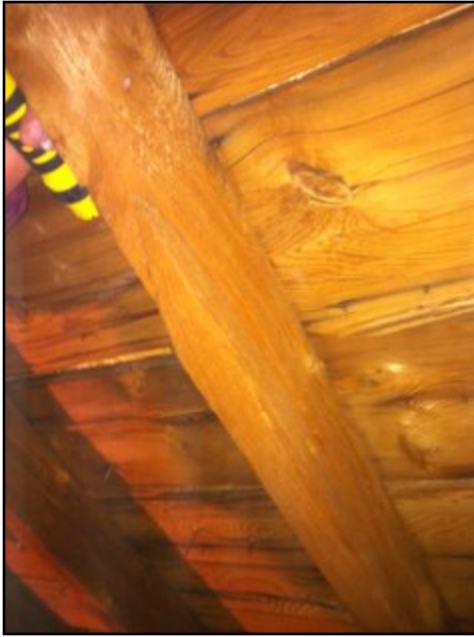
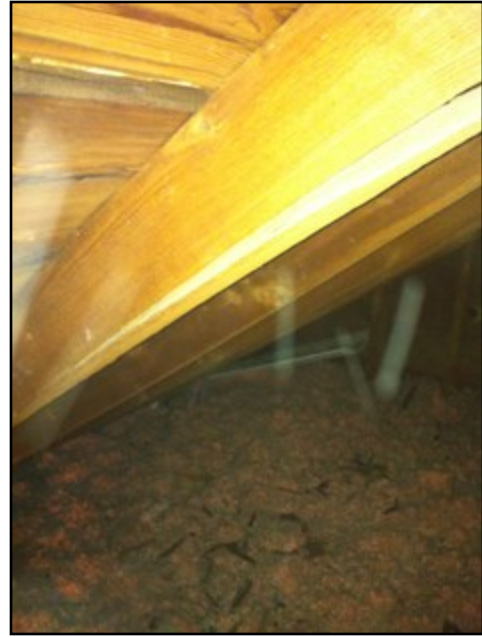
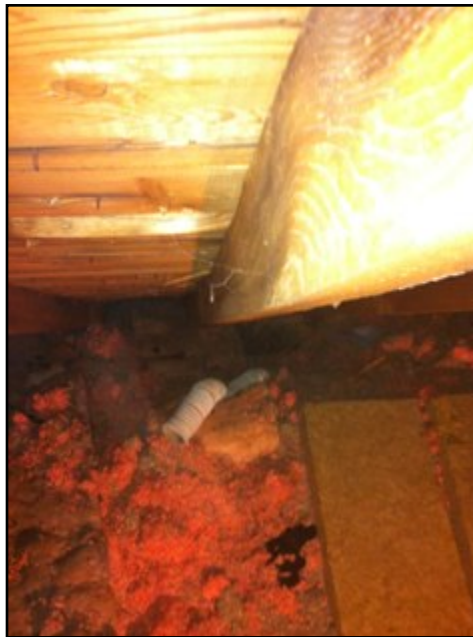
Condition: • [Ridge sagging](#)

Implication(s): Weakened structure | Chance of structural movement

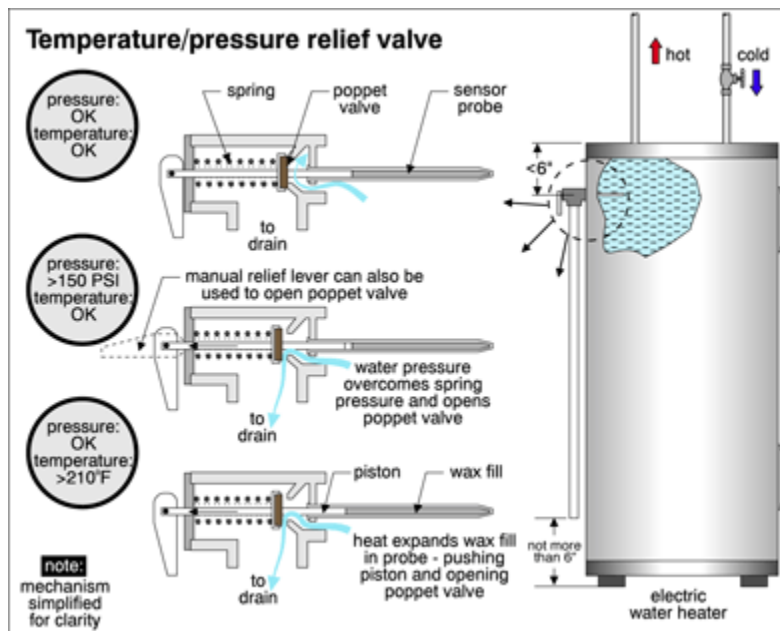
Condition: • [Discharge tube missing](#)

Task: Replace

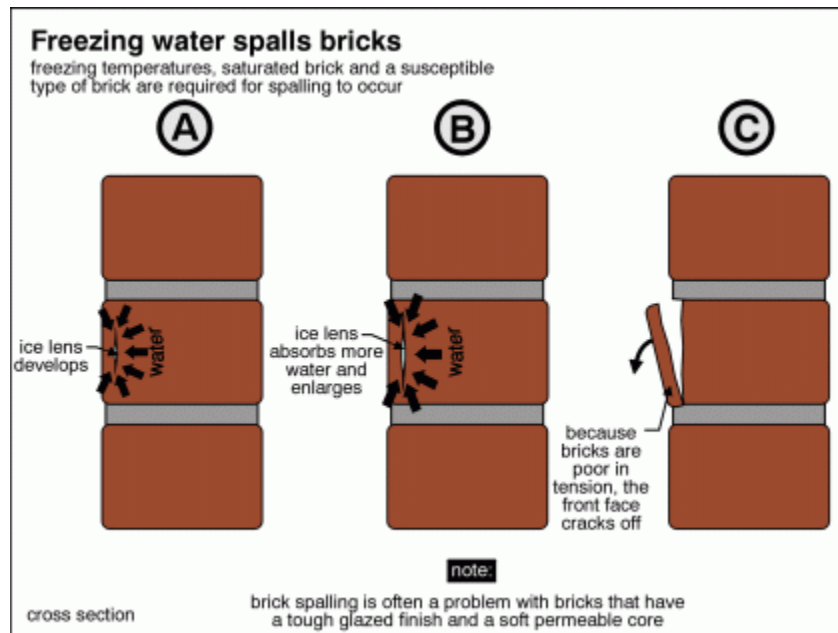
Condition: • [Spalling](#)

Implication(s): Cosmetic defects | Weakened structure | Chance of structural movement

Task: Repair or replace

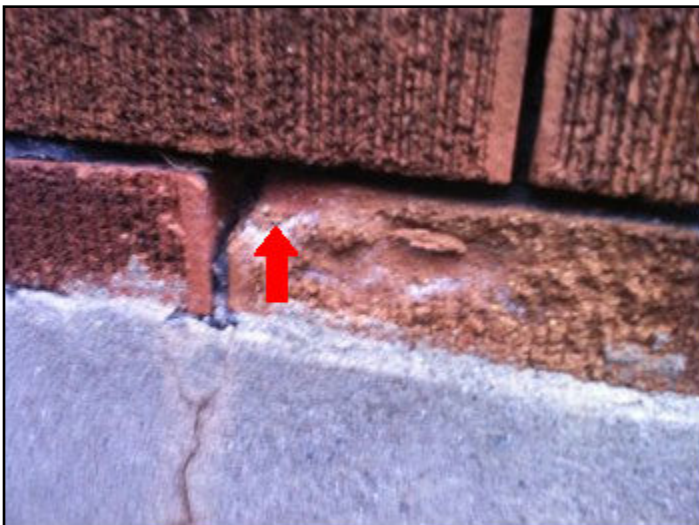
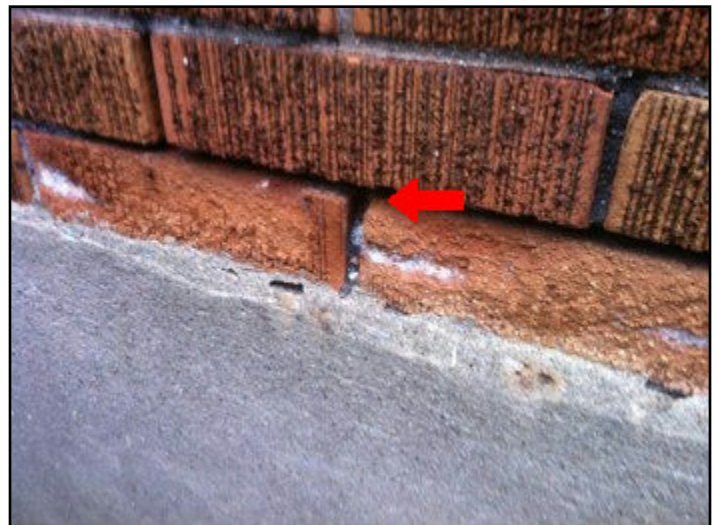
Condition: • [Mortar deterioration](#)

Implication(s): Chance of water entering house | Weakened structure | Chance of structural movement

Task: Repair

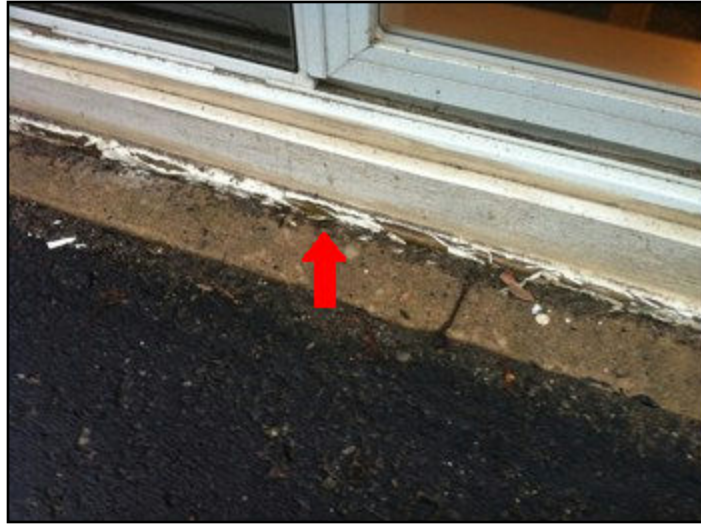
Condition: • [Caulking loose, missing or deteriorated](#)

Implication(s): Chance of water damage to contents, finishes and/or structure | Increased heating and cooling costs

Task: Replace

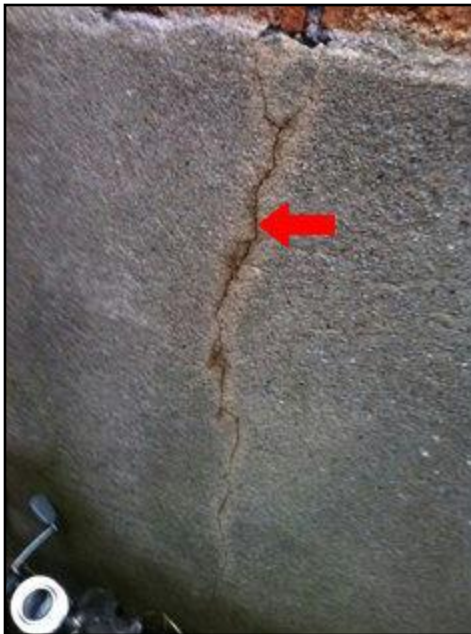
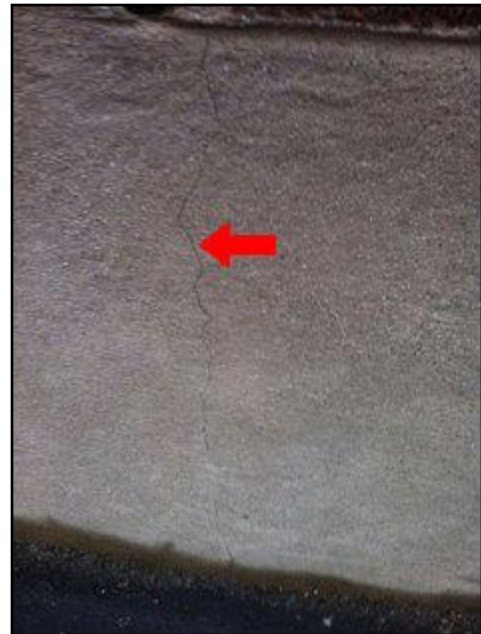
Condition: • [Spalling, crumbling or broken material](#)

Implication(s): Weakened structure | Chance of structural movement

Task: Repair

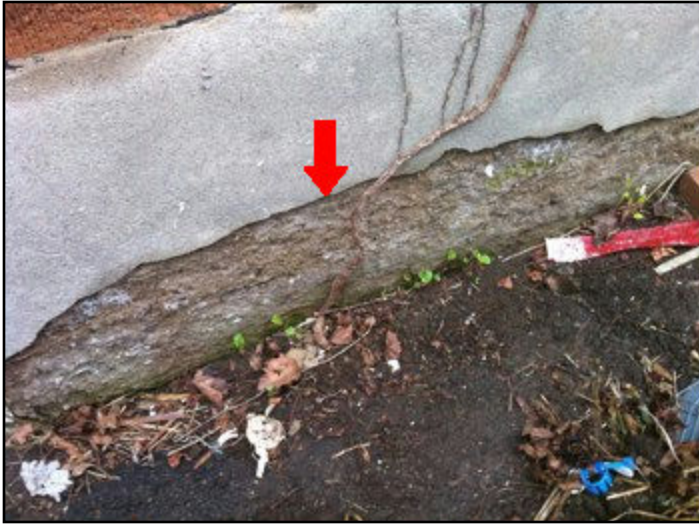
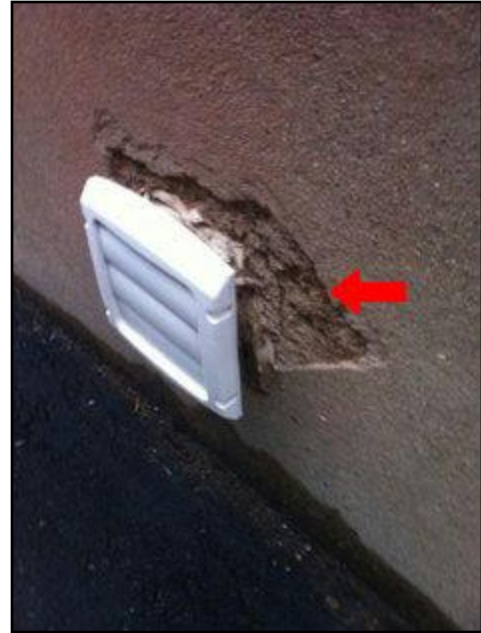
Condition: • [Parging damaged or missing](#)

Implication(s): Chance of damage to structure | Shortened life expectancy of material

Task: Repair or replace

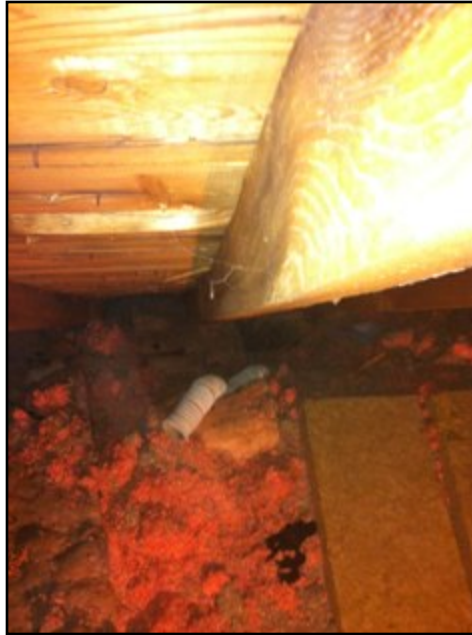
Condition: • [Ridge sagging](#)

Implication(s): Weakened structure | Chance of structural movement

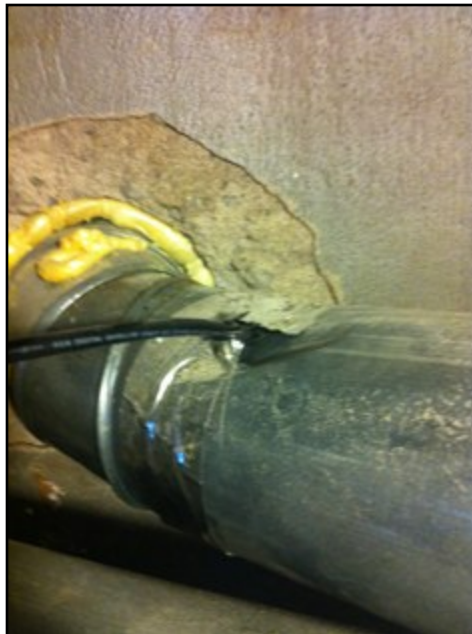
Condition: • Coaxial cable feeding through heat supply duct

Task: Correct
