Your Inspection Report

123 Somestreet Ave
Durham Region, ON

INSPECTION DATE:
Friday, April 19, 2013

RE: Report No. 1148, v.2
123 Somestreet Ave
Durham Region, ON

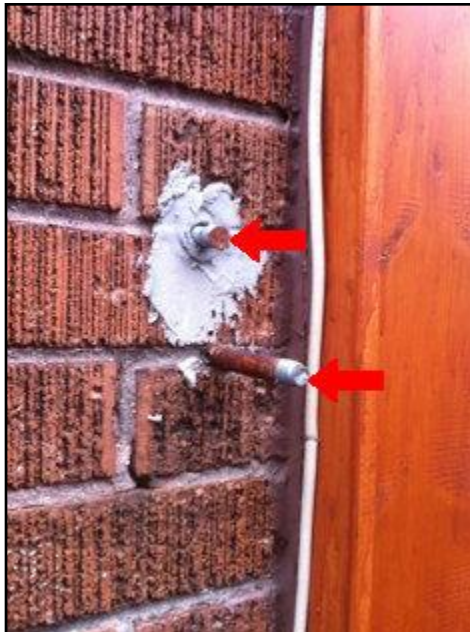
Condition: • Bolts protruding from wall

Location: Exterior Wall

Task: Improve

Time: Immediate

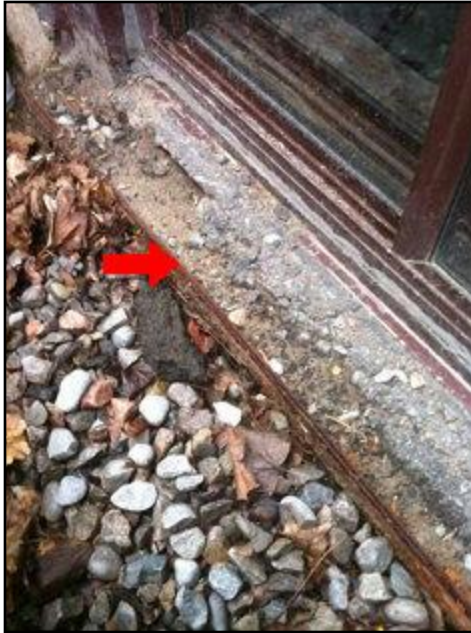
Condition: • [Sill deteriorated](#)

Implication(s): Material deterioration

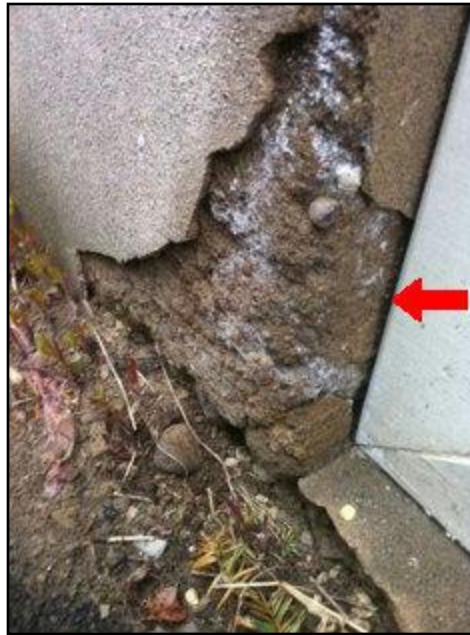
Condition: • [Parging damaged or missing](#)

Implication(s): Chance of damage to structure | Shortened life expectancy of material

Task: Repair or replace

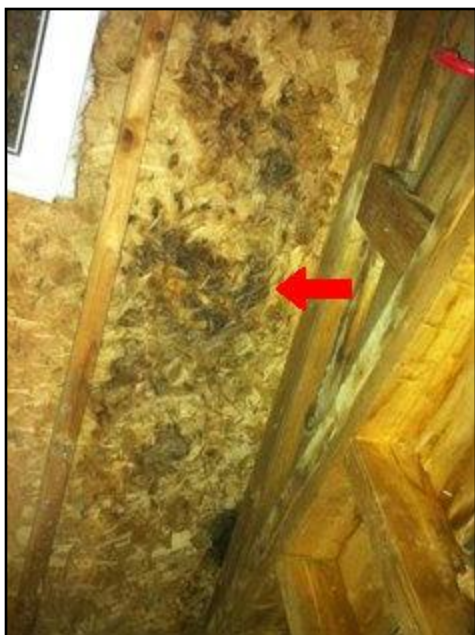
Condition: • [Water stains](#)

Implication(s): Material deterioration

Task: Repair or replace

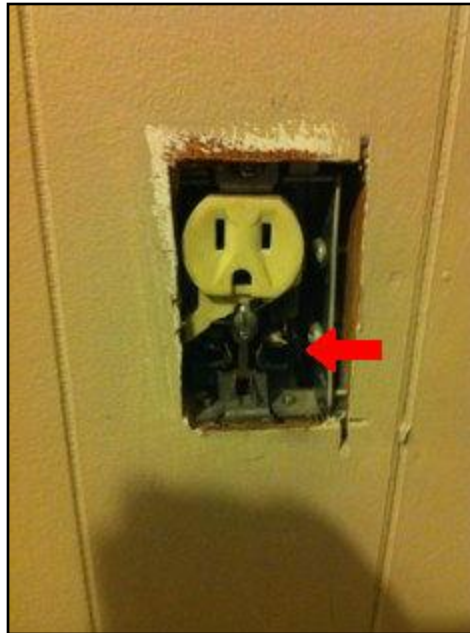
Condition: • [Damage](#)

Outlet is live. Fire hazard

Implication(s): Electric shock | Fire hazard

Task: Replace

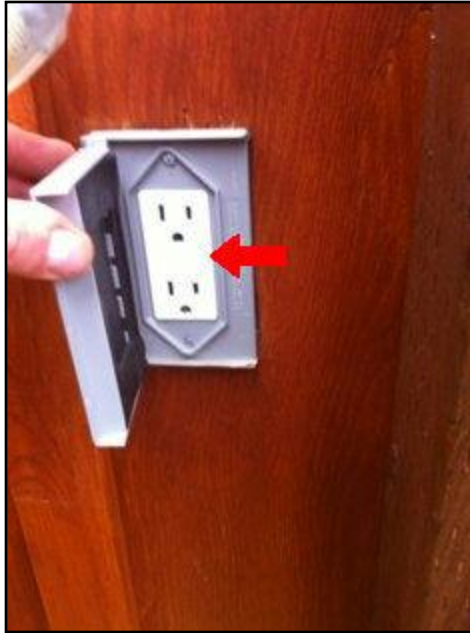
Condition: • [No GFI \(Ground Fault Interrupter\)](#)

Implication(s): Electric shock

Task: Replace

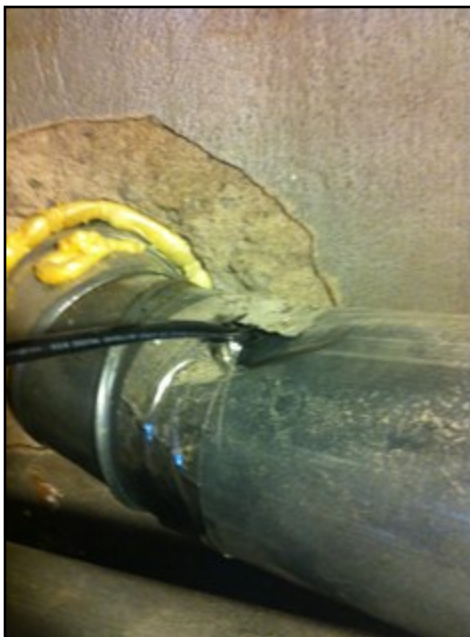
Condition: • Coaxial cable feeding through heat supply duct

Task: Correct

Time: Immediate

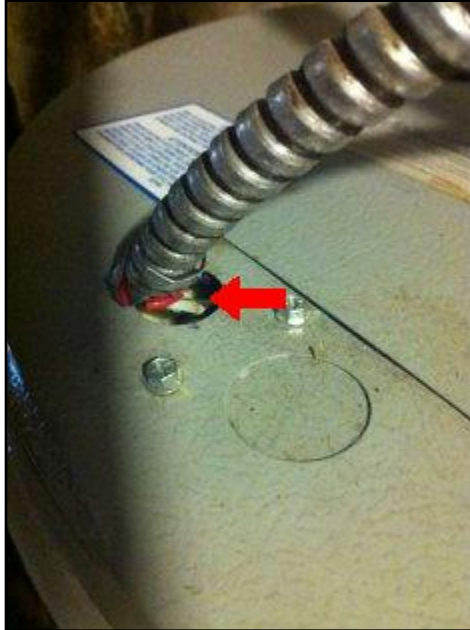
Condition: • Wiring not properly secured

Task: Repair

Time: Immediate

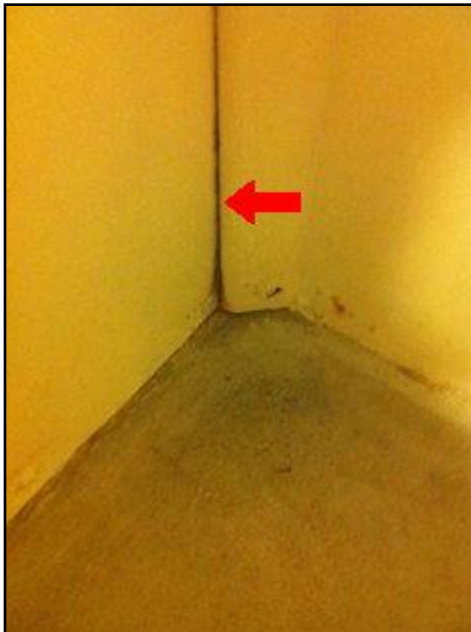
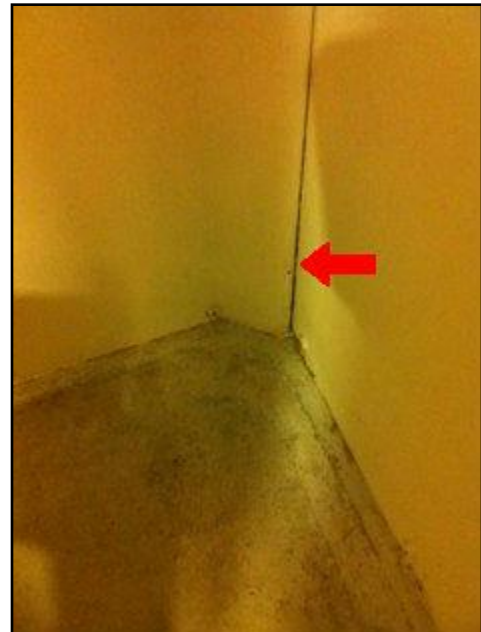
Condition: • [Grout loose, missing or deteriorated](#)

Implication(s): Chance of water damage to contents, finishes and/or structure

Task: Replace

Time: Immediate

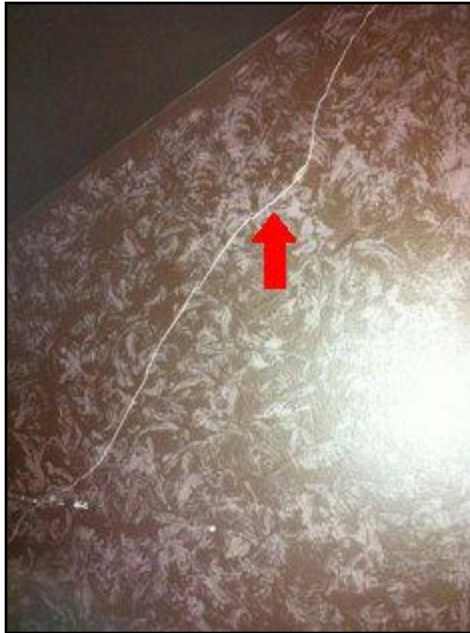
Condition: • [Cracked](#)

Implication(s): Cosmetic defects

Task: Repair

Time: When remodelling

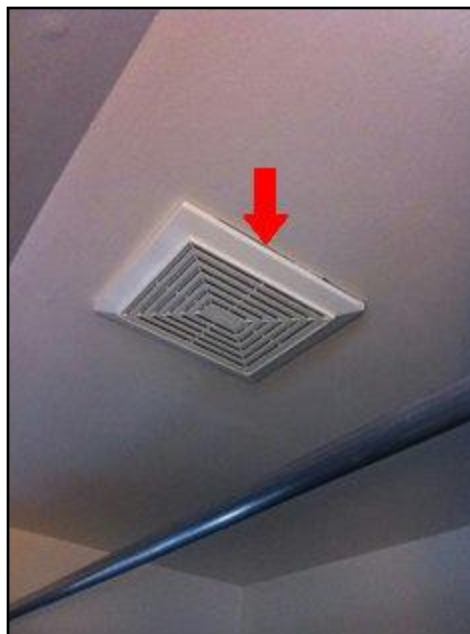
EXHAUST FANS \ Exhaust duct

Condition: • [Poor termination location](#)

Implication(s): Chance of condensation damage to finishes and/or structure

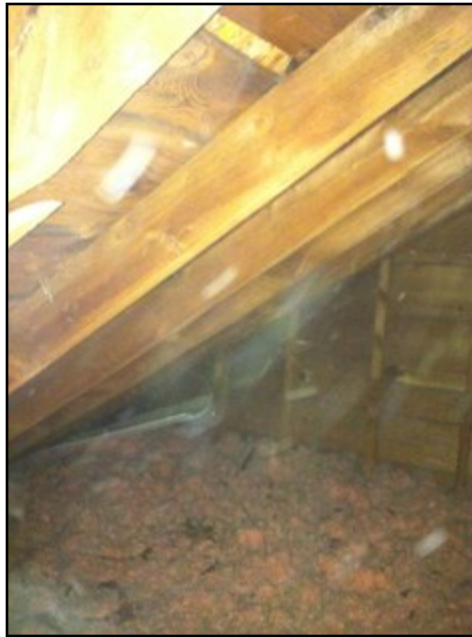
Condition: • Typical minor cracks

Task: Monitor

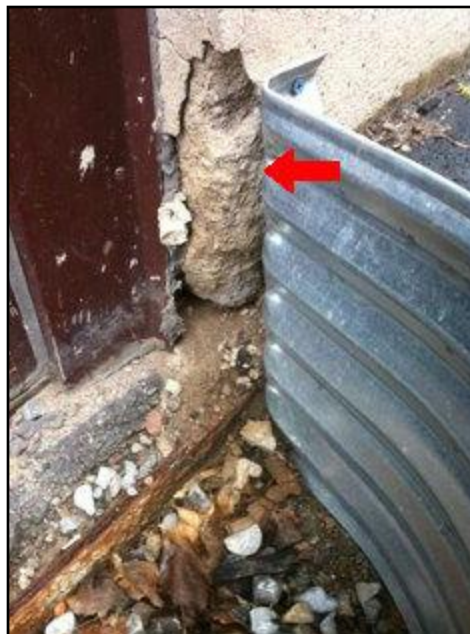
Condition: • [Parging damaged or missing](#)

Implication(s): Chance of damage to structure | Shortened life expectancy of material

Task: Repair or replace

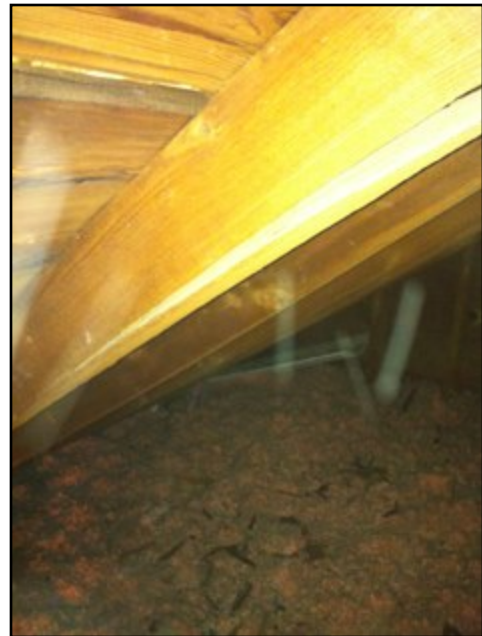
Condition: • [Sagging](#)

Task: Repair

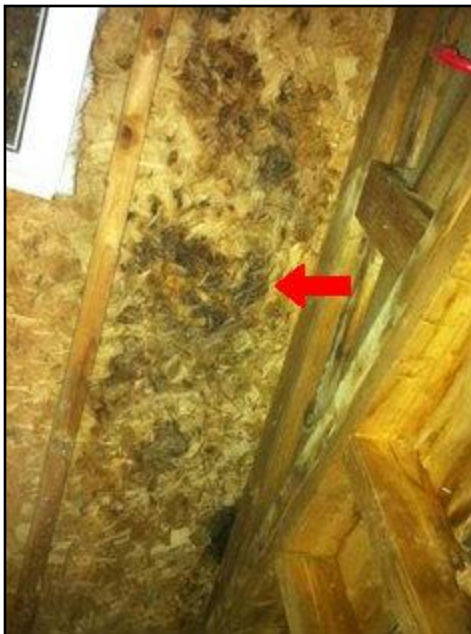
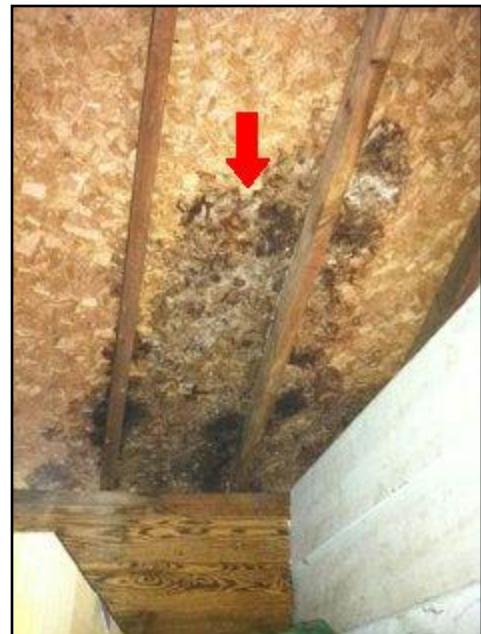
Condition: • [Water stains](#)

Implication(s): Material deterioration

Task: Repair or replace

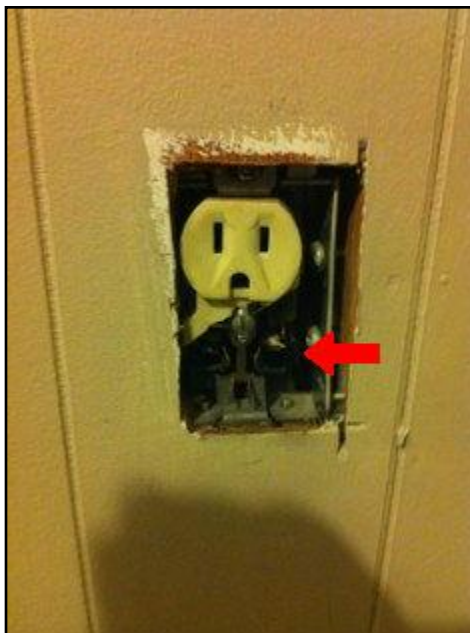
Condition: • [No GFI \(Ground Fault Interrupter\)](#)

Implication(s): Electric shock

Task: Replace

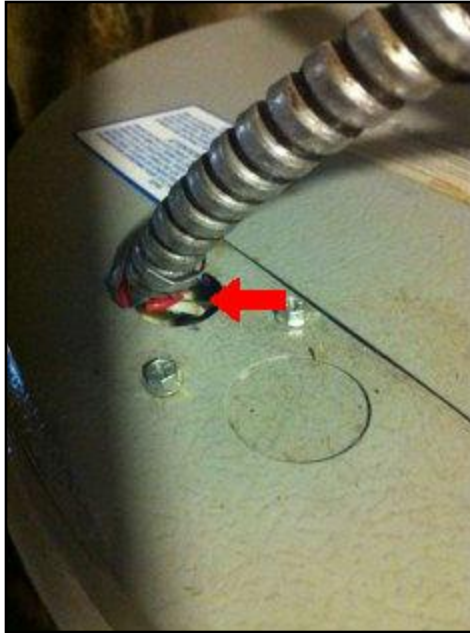
FIXTURES AND FAUCETS \ Shower stall

Condition: • Unfinished with electrical running above.

Task: Correct

Time: Immediate

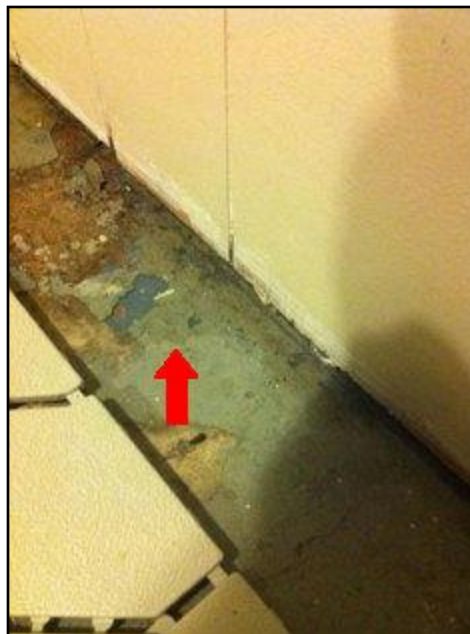
WALLS \ Plaster or drywall

Condition: • [Cracked](#)

Implication(s): Cosmetic defects

Task: Repair

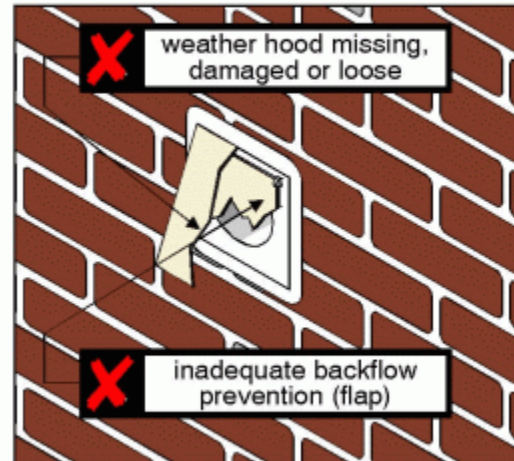
Condition: • [Inoperative](#)

Implication(s): Chance of condensation damage to finishes and/or structure

Task: Repair or replace

Time: Immediate

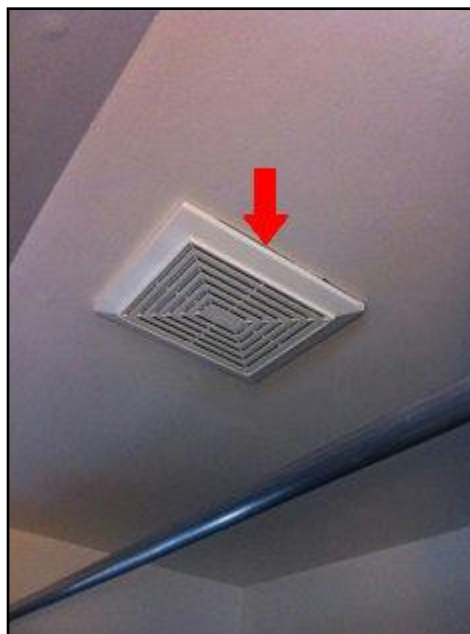
EXHAUST FANS \ Exhaust duct

Condition: • [Poor termination location](#)

Implication(s): Chance of condensation damage to finishes and/or structure

Task: Correct

Time: Immediate
